**RADC-TR-78-267**  
Final Technical Report  
January 1979

## **PRELIDDING BURN—IN EVALUATION**

**Raytheon Company**

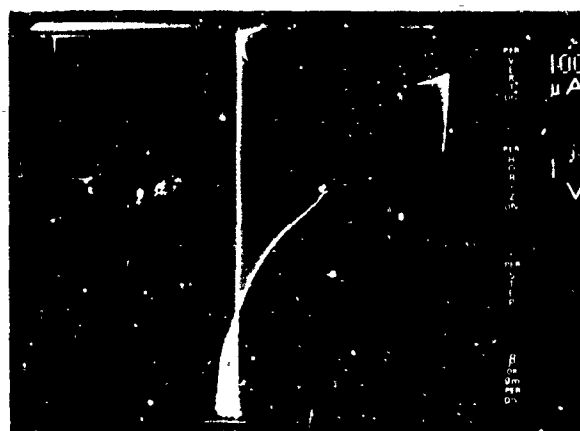
Figure E-4 - T121-05, Current-Voltage Characteristics, Observed at Output of IC3 With Multivibrator Running (Center of Gradicule = 0)

<u>S/N</u>	<u>No.</u>	<u>Failure Location</u>
T111-07	138	Output Section of IC4
T121-05	101	Degradation of Input Gate Oxide I2
T421-12	125	FF3/4 I.C. Failure Verified
Control	146	Degradation of Input Gate Oxide I2
T211-13	139	Degradation of IC4
C021-10	7	Overstressed pin 2

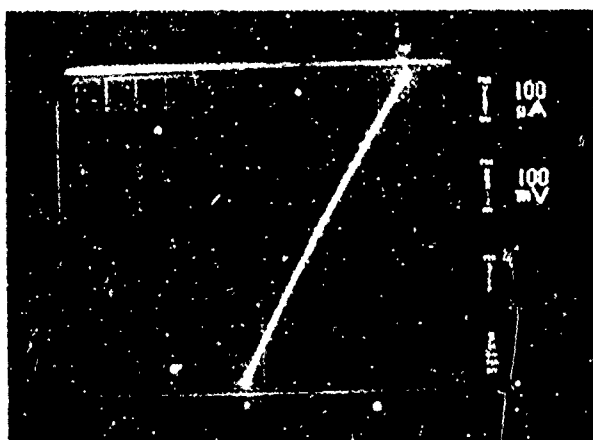
Figure E-6 - T211-13, Current-Voltage Characteristics Observed At Output of IC4 (IC4 Is In Low State) Center of Gradicule = 0
